# Rio Vista Natural Resource Park, 1936–2021: A History of Land Cover Change

Report RVCP 23-01

# Rio Vista Natural Resource Park, 1936-2021

A history of land cover change by Julia Fonseca

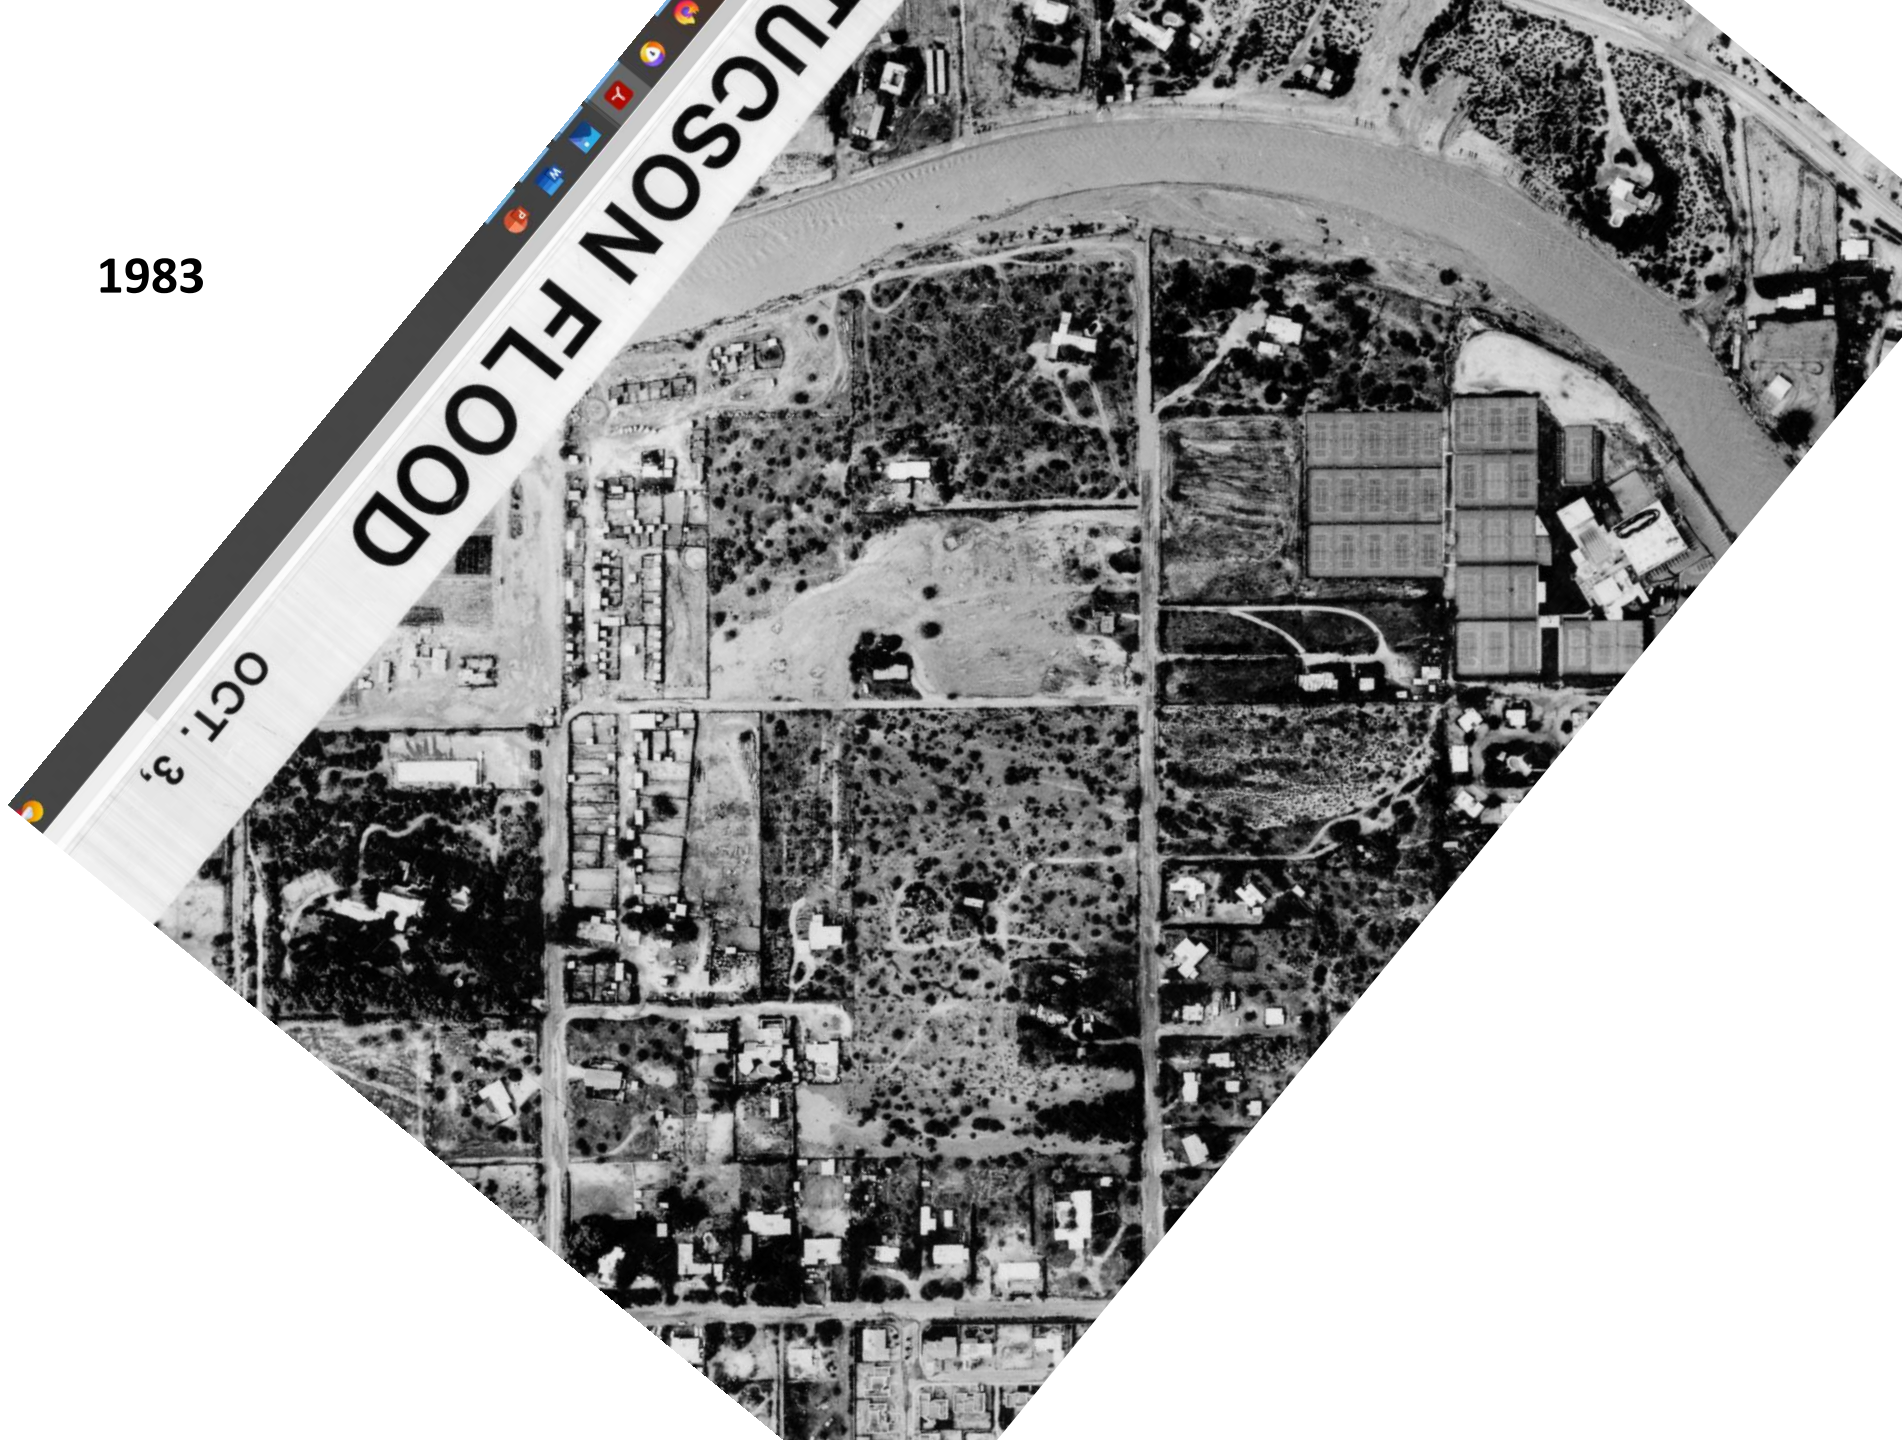
# TUCSON FLOOD

OCT. 3,

During the 1970s and early 1980s, more land in the park area was cleared of vegetation for horse operations and houses. Soil-cement embankments were constructed after the 1983 flood.
