A History of Land Cover Change at Rio Vista Park

Julia Fonseca, Madrean Resources

**Rio Vista Natural Resource Park, 1936–2021:
A History of Land Cover Change**

Report submitted to:
Friends of Rio Vista
P.O. Box 65693
Tucson, Arizona 85728
Report RVCP 23-01

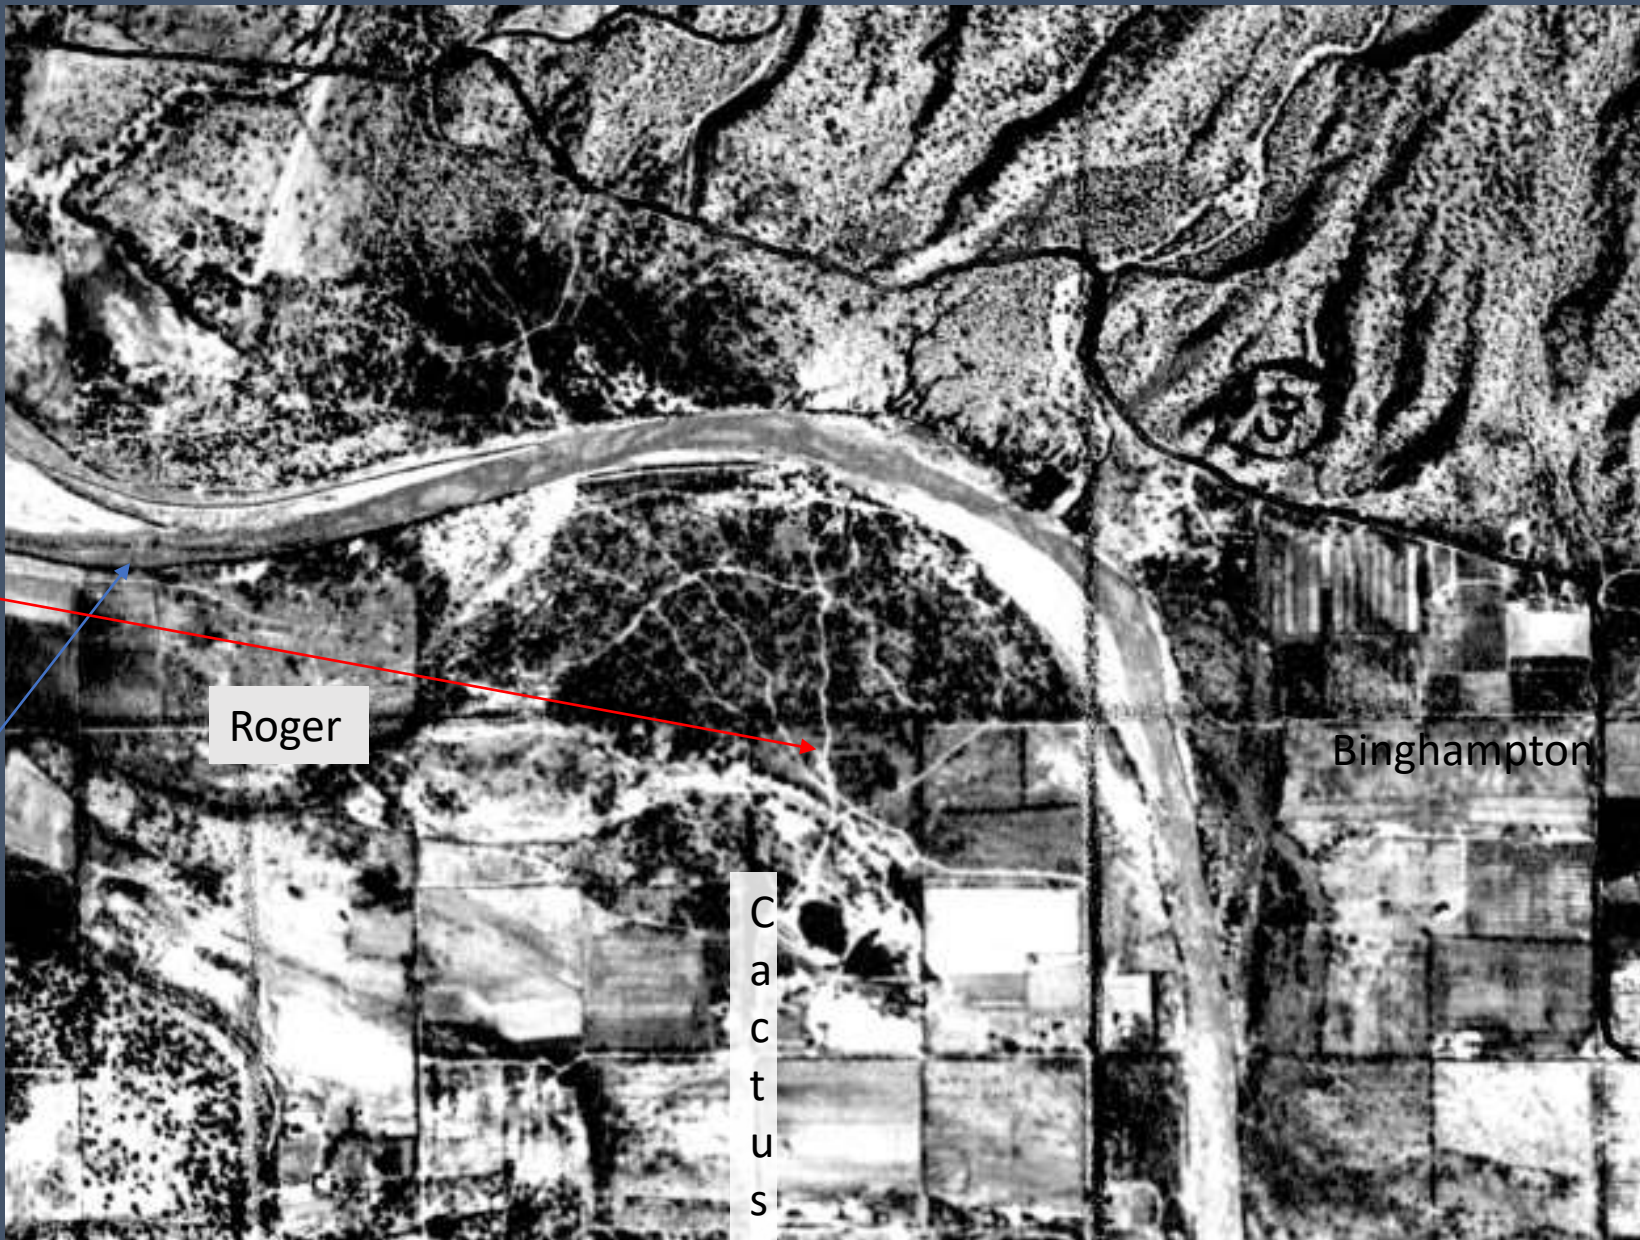
1936

- Flows
- Livestock trails
- Pits
- Swale
- Clearing

Underflow ditch and flume, Rillito, Special Collections, University of Arizona circa 1908

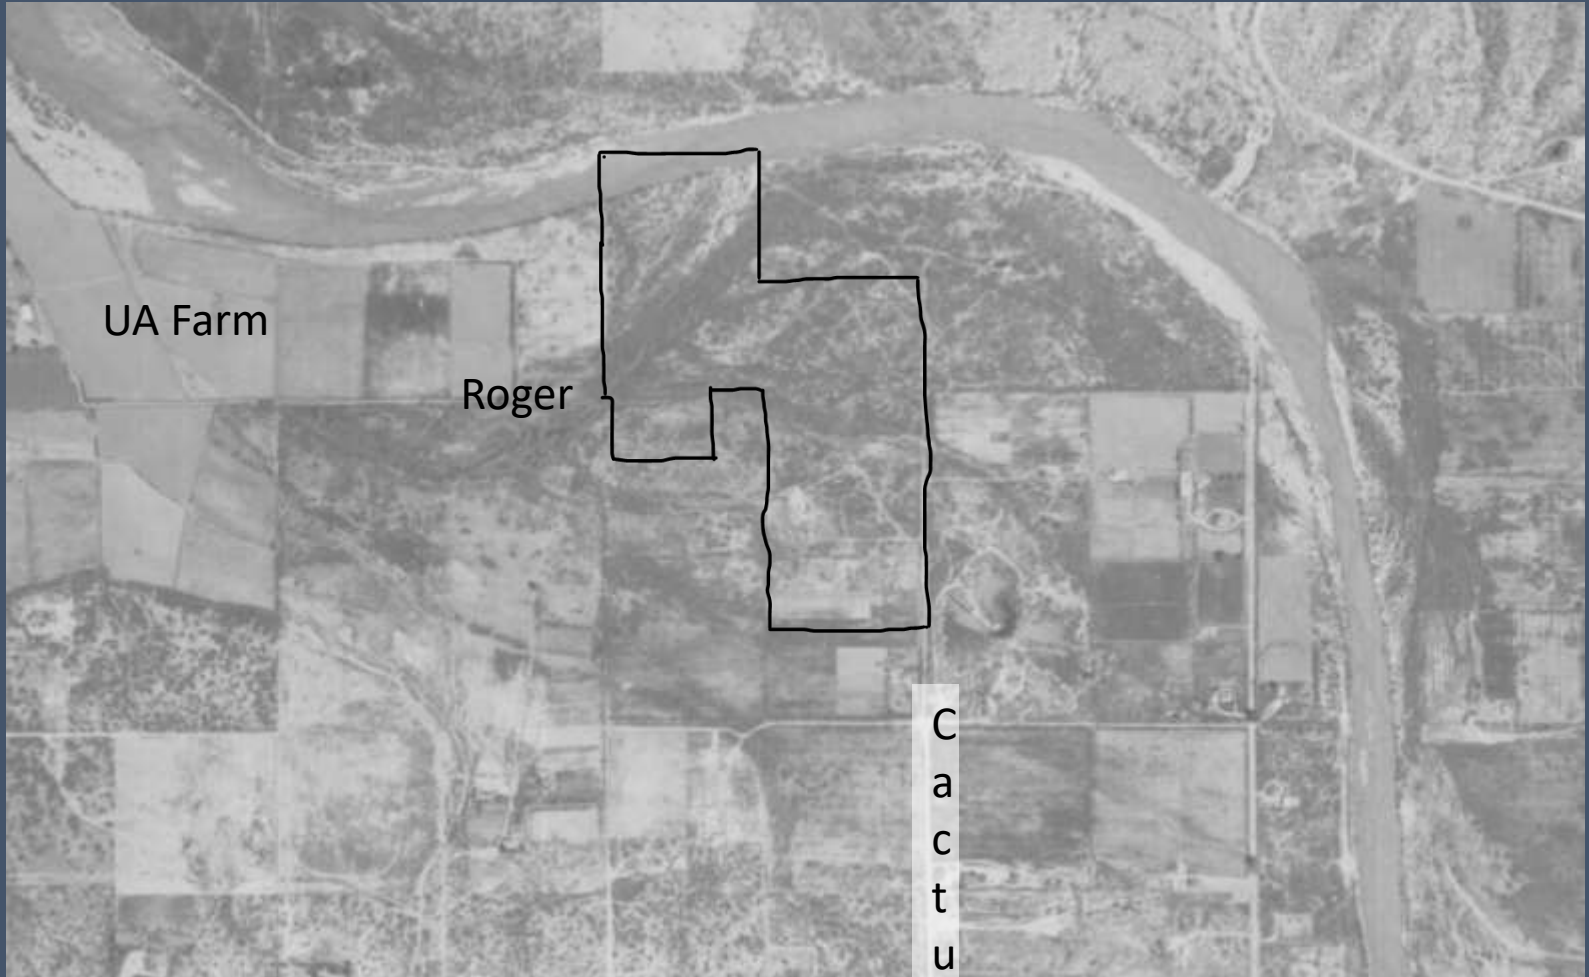
1941

Livestock
Clearing
Roads

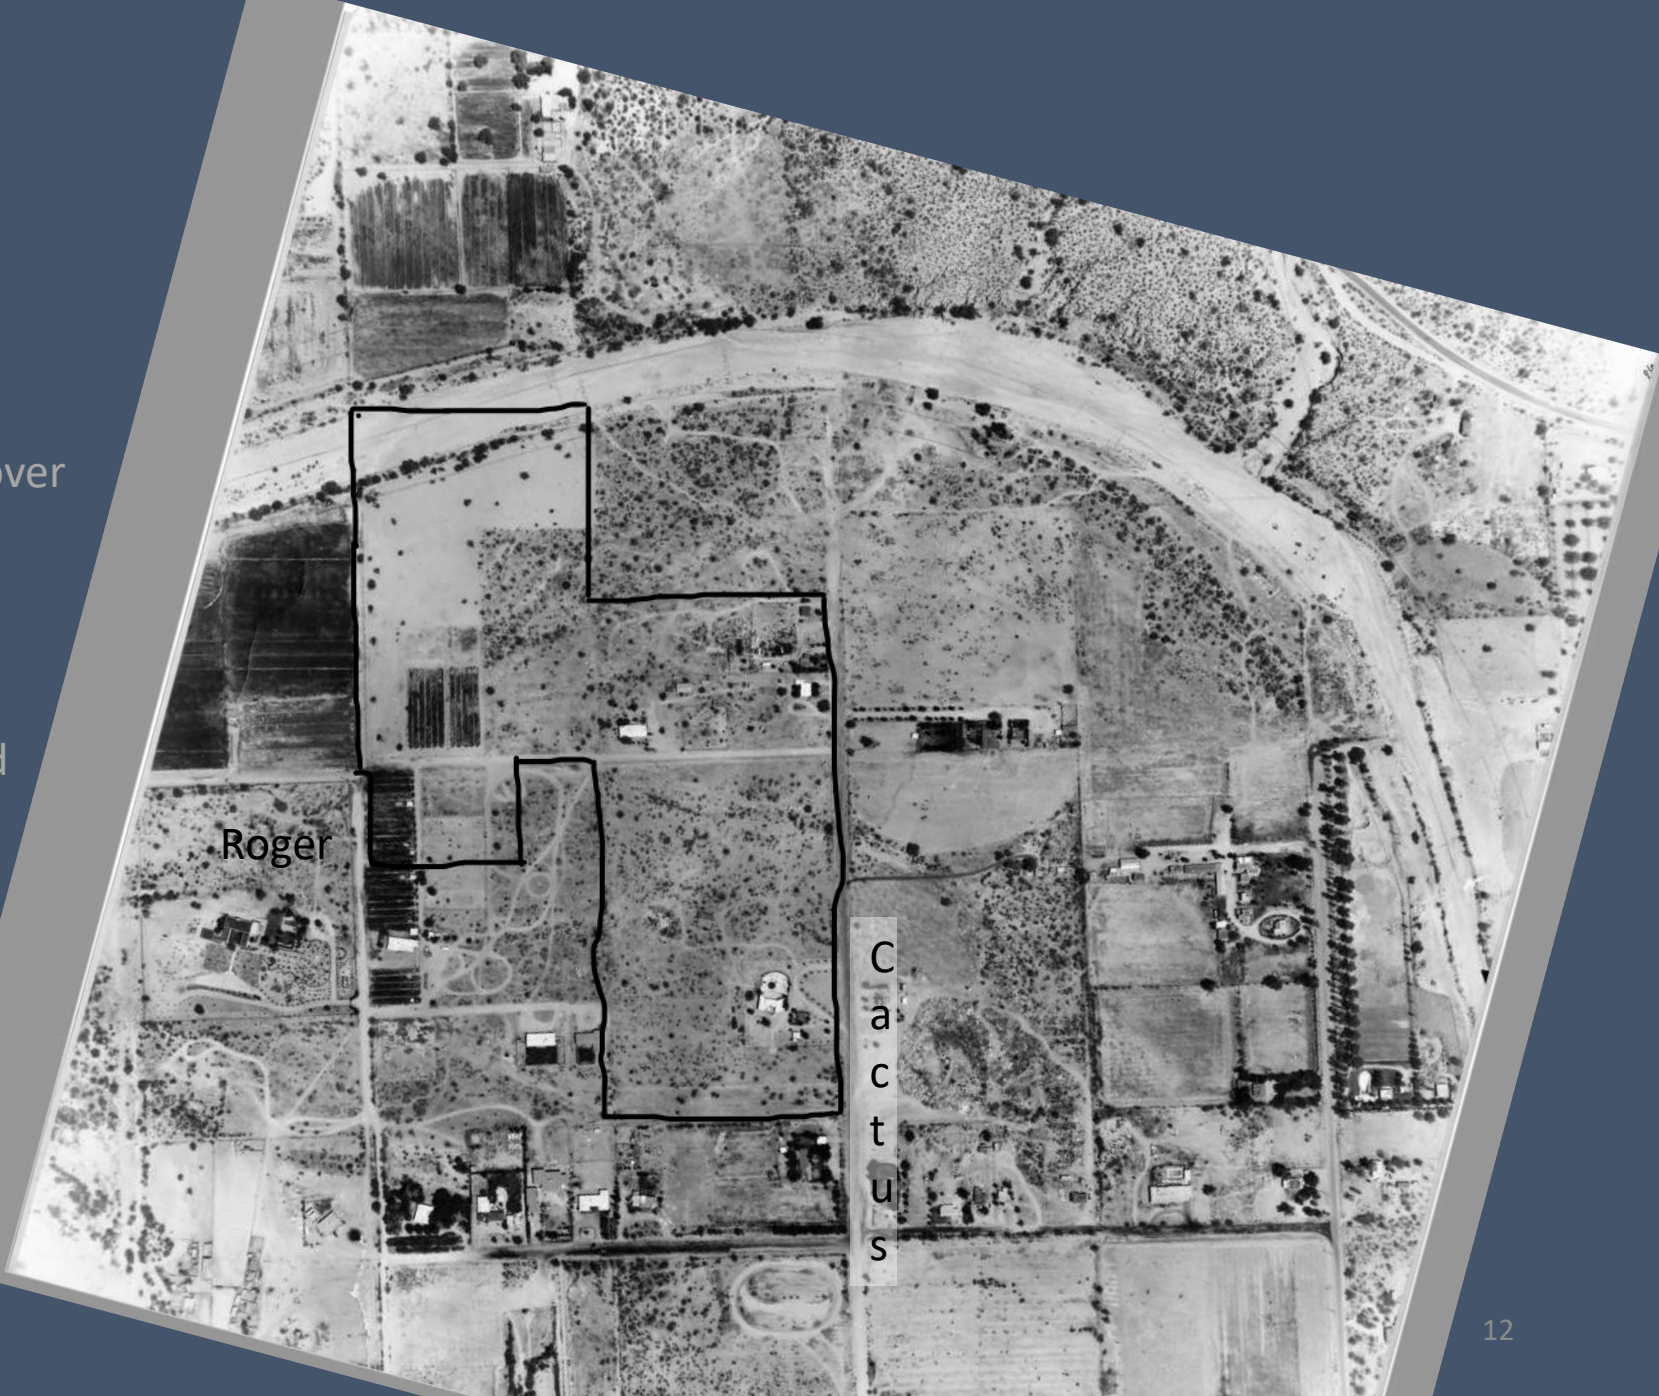
1959

No flow
Reduced cover
Clearing
Irrigation
Row crops?
Structures
Tucson Blvd
.Roger Rd.
Landfill

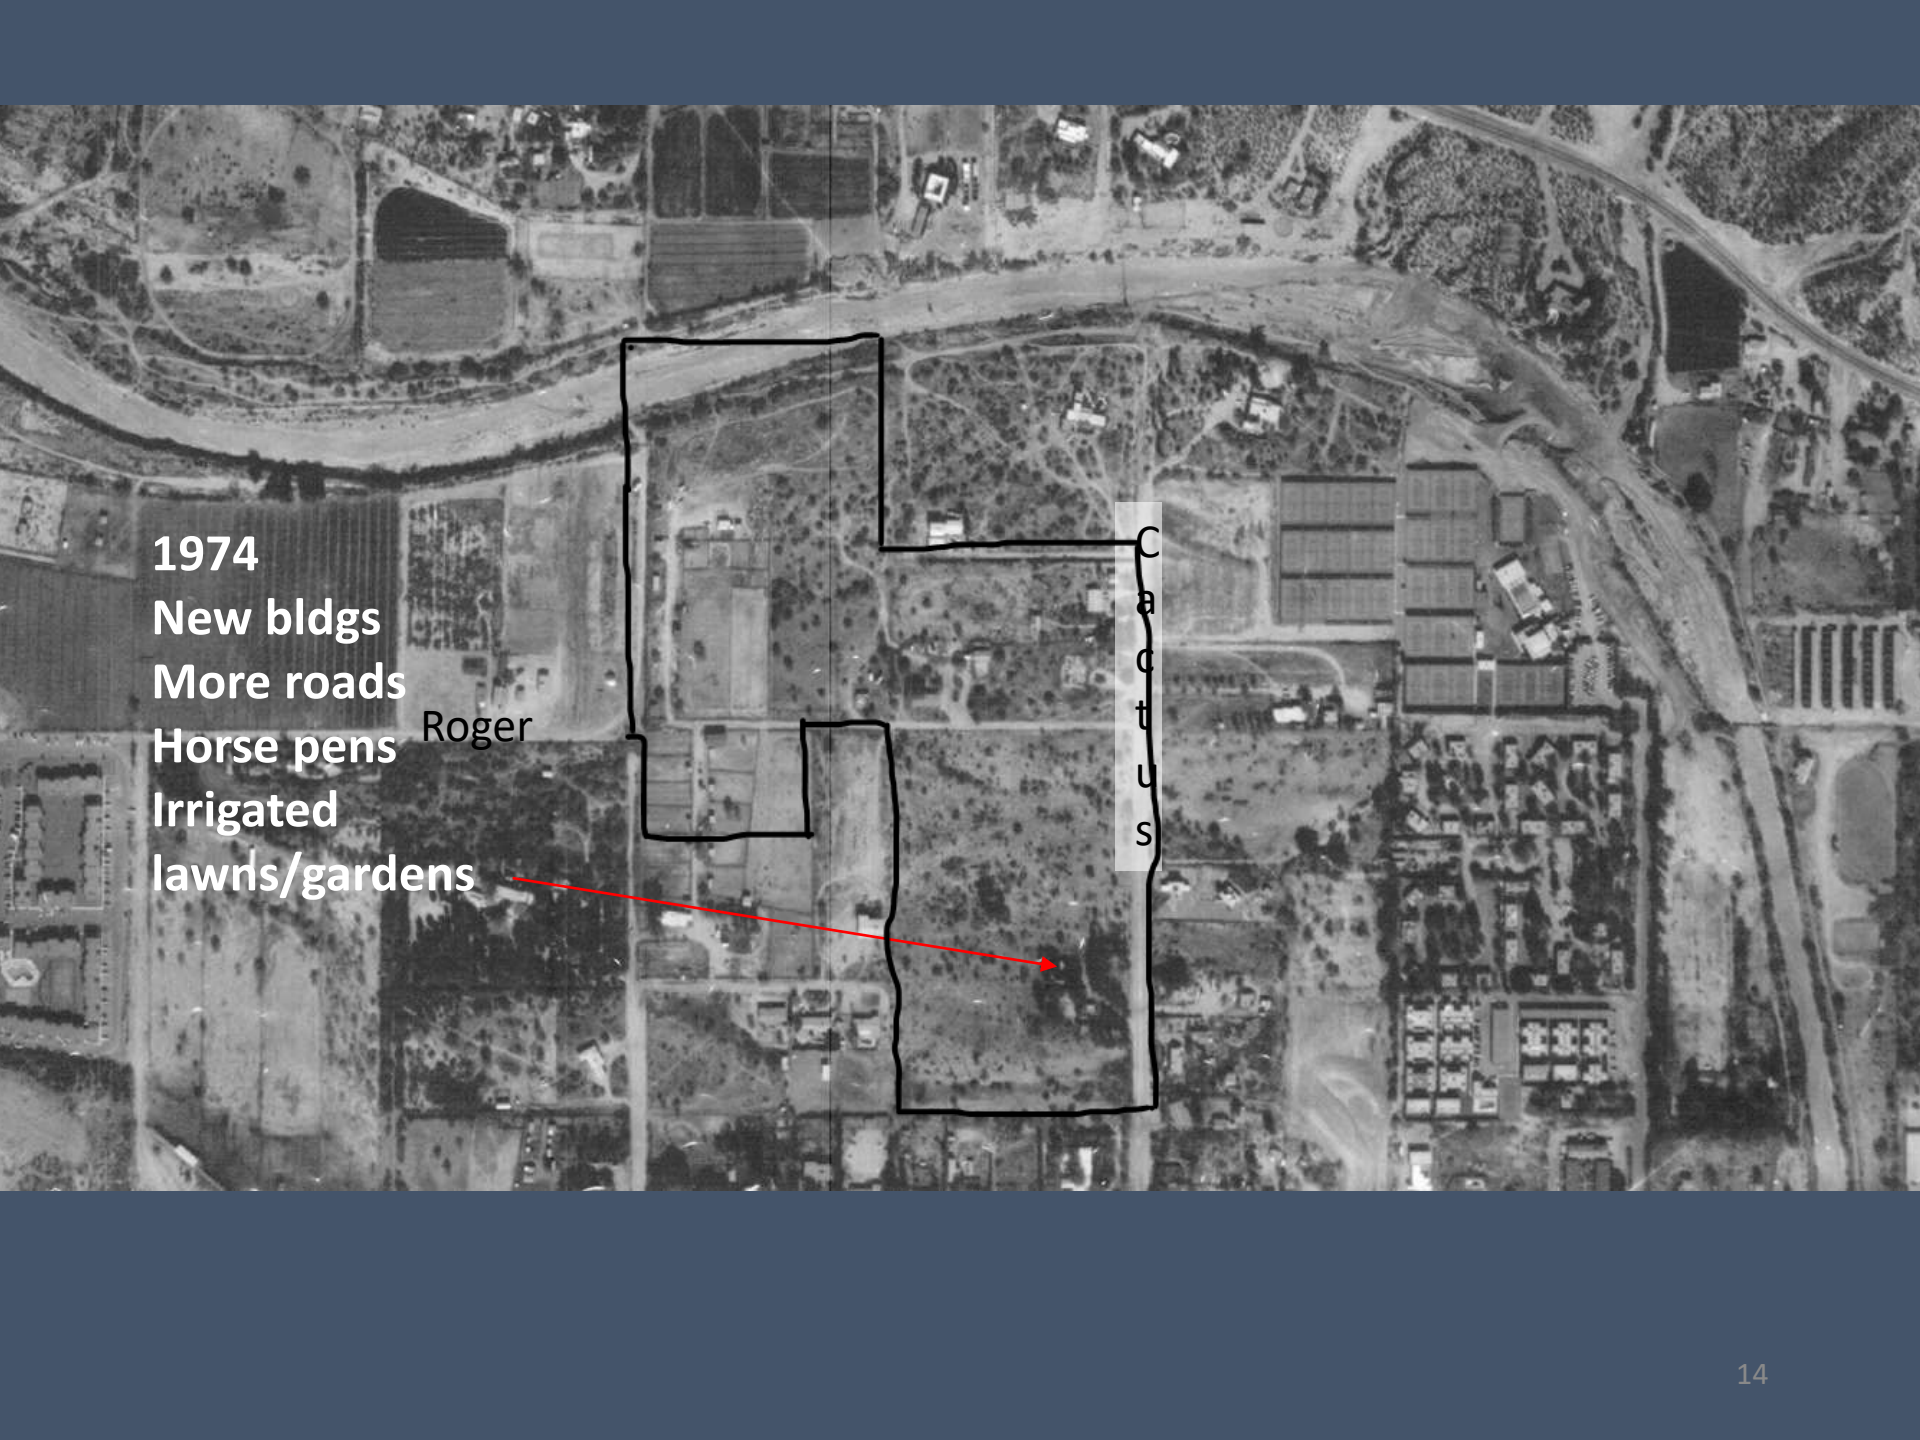
1974
New bldgs
More roads
Horse pens
Irrigated
lawns/gardens

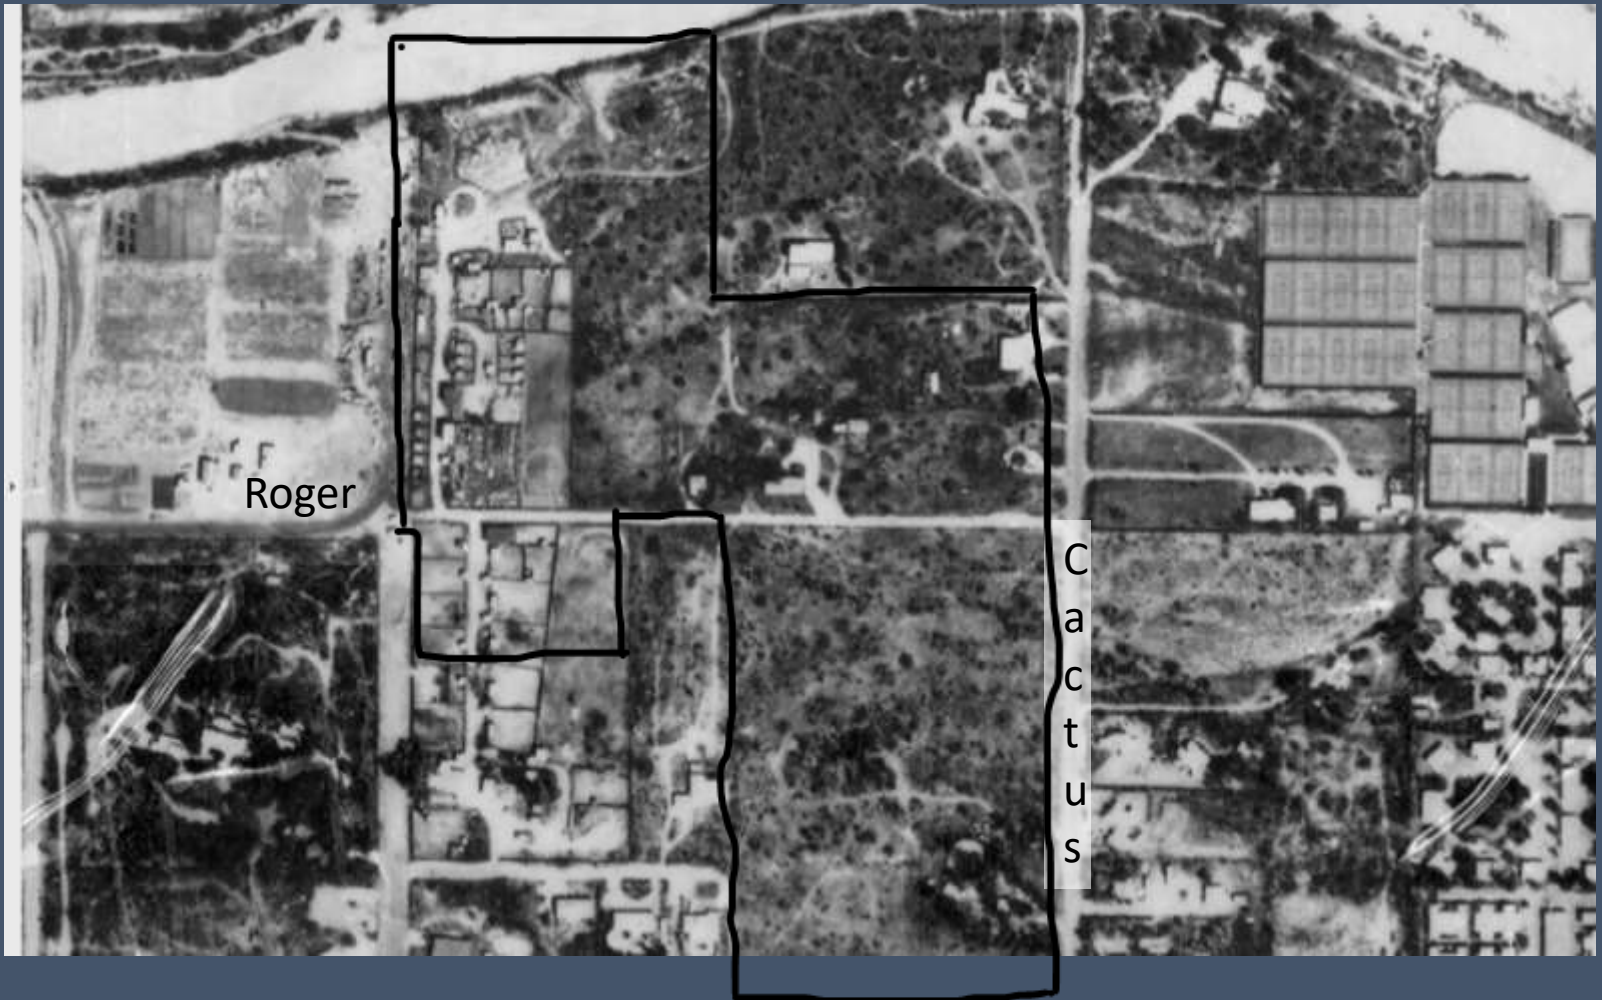
1980

Clearings, more intensive horse use, Tucson Blvd. widened

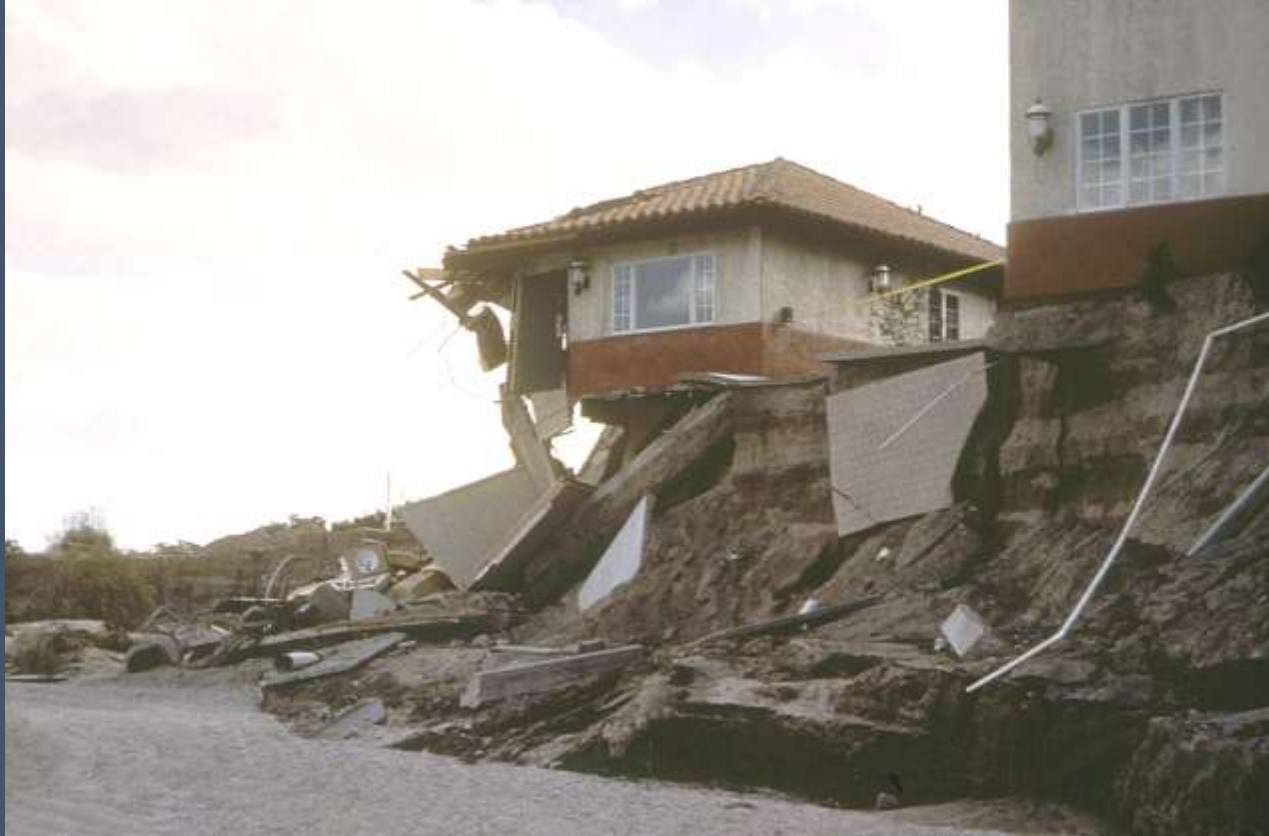
1983

More clearing
Domestic and
livestock use
continue
Sand bar

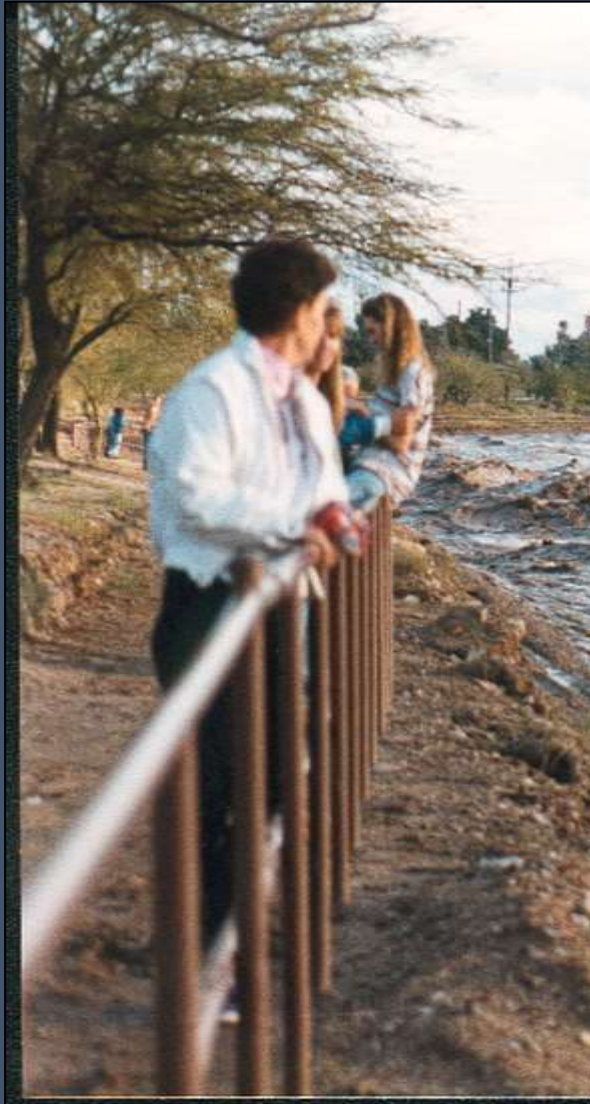
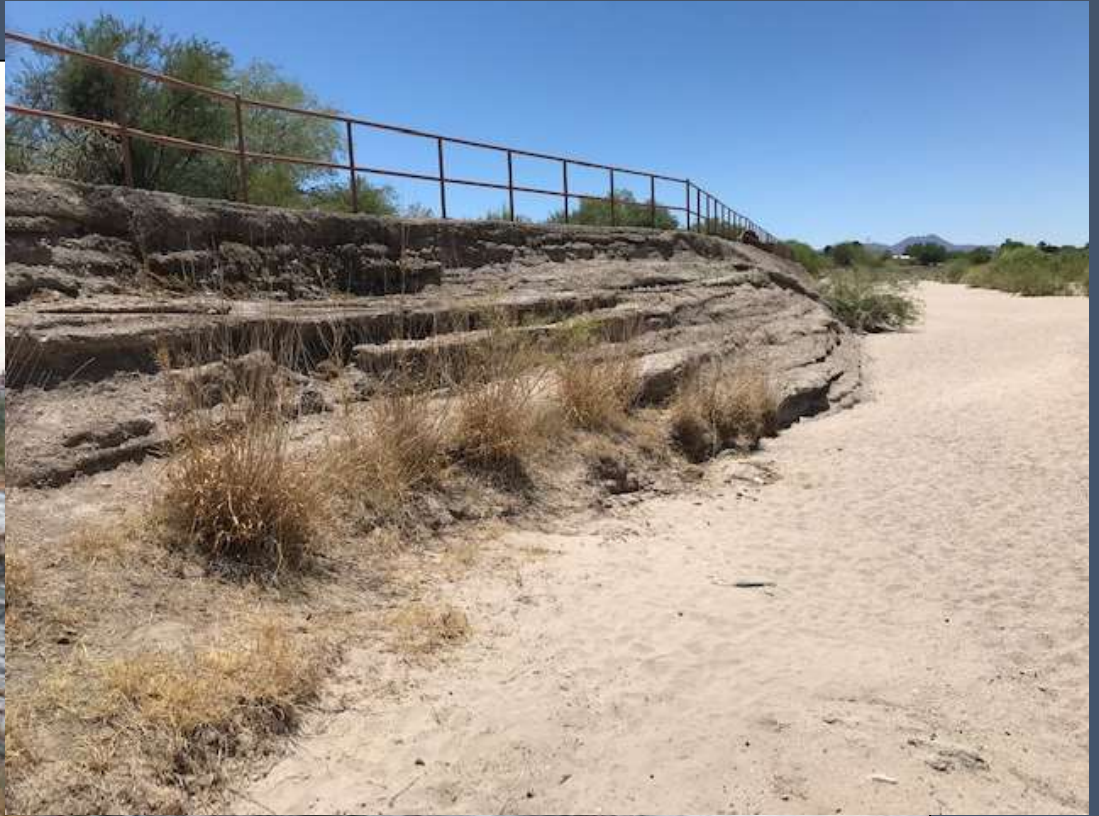
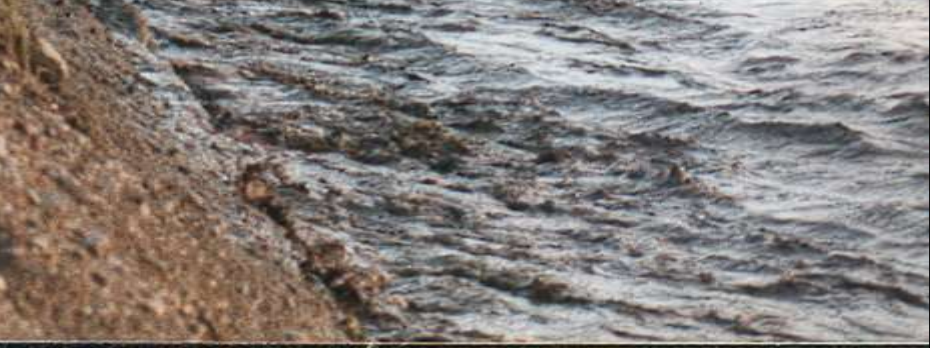
Soil-cement embankments along Santa Cruz and Rillito

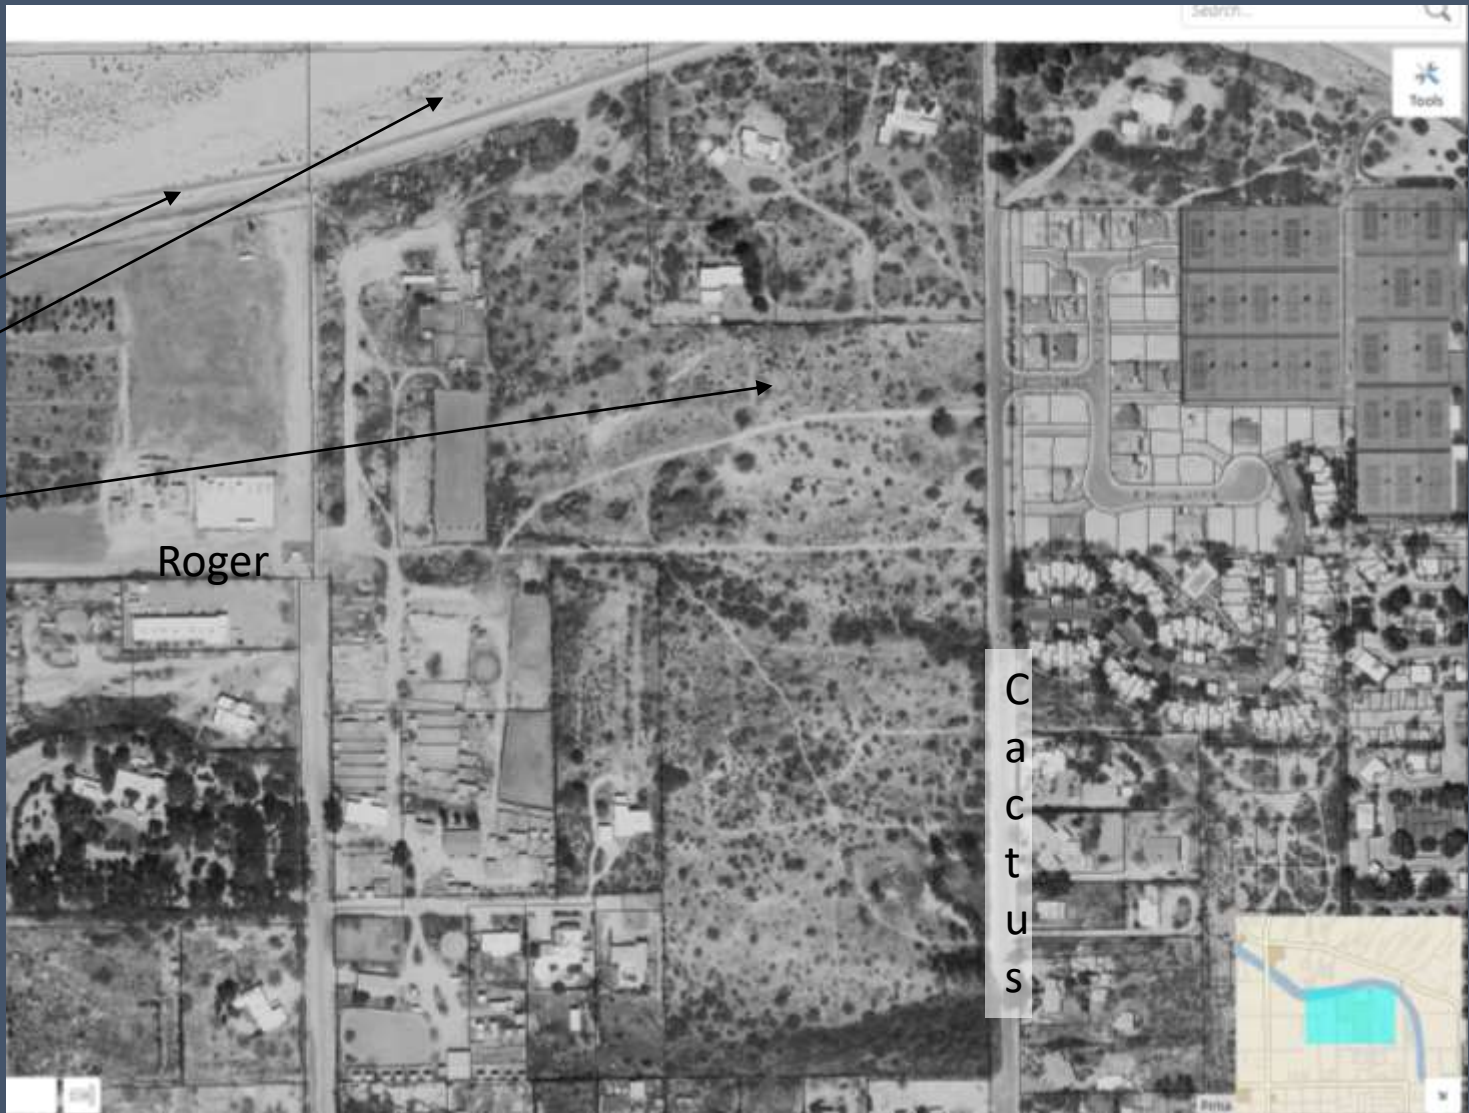
1998

Soil cement
Sand bar
growth
Vegetation
Recovery
Thicker
riparian

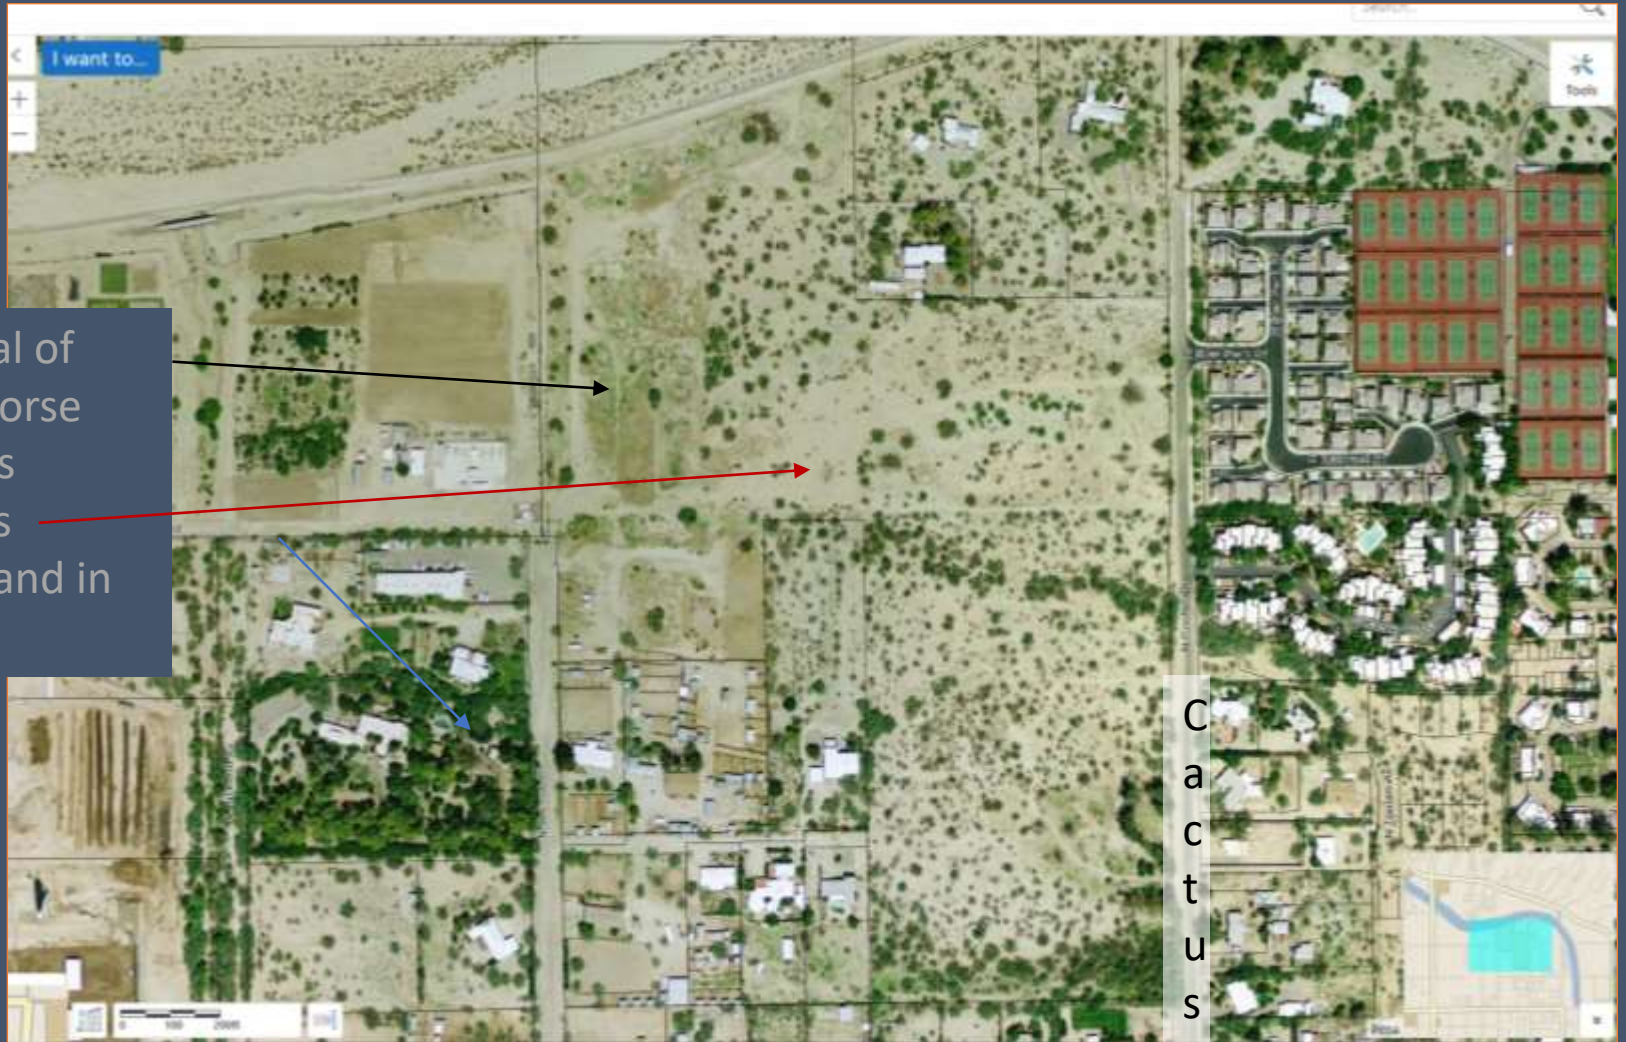
2002

Removal of
some horse
facilities
Veg loss
More sand in
river

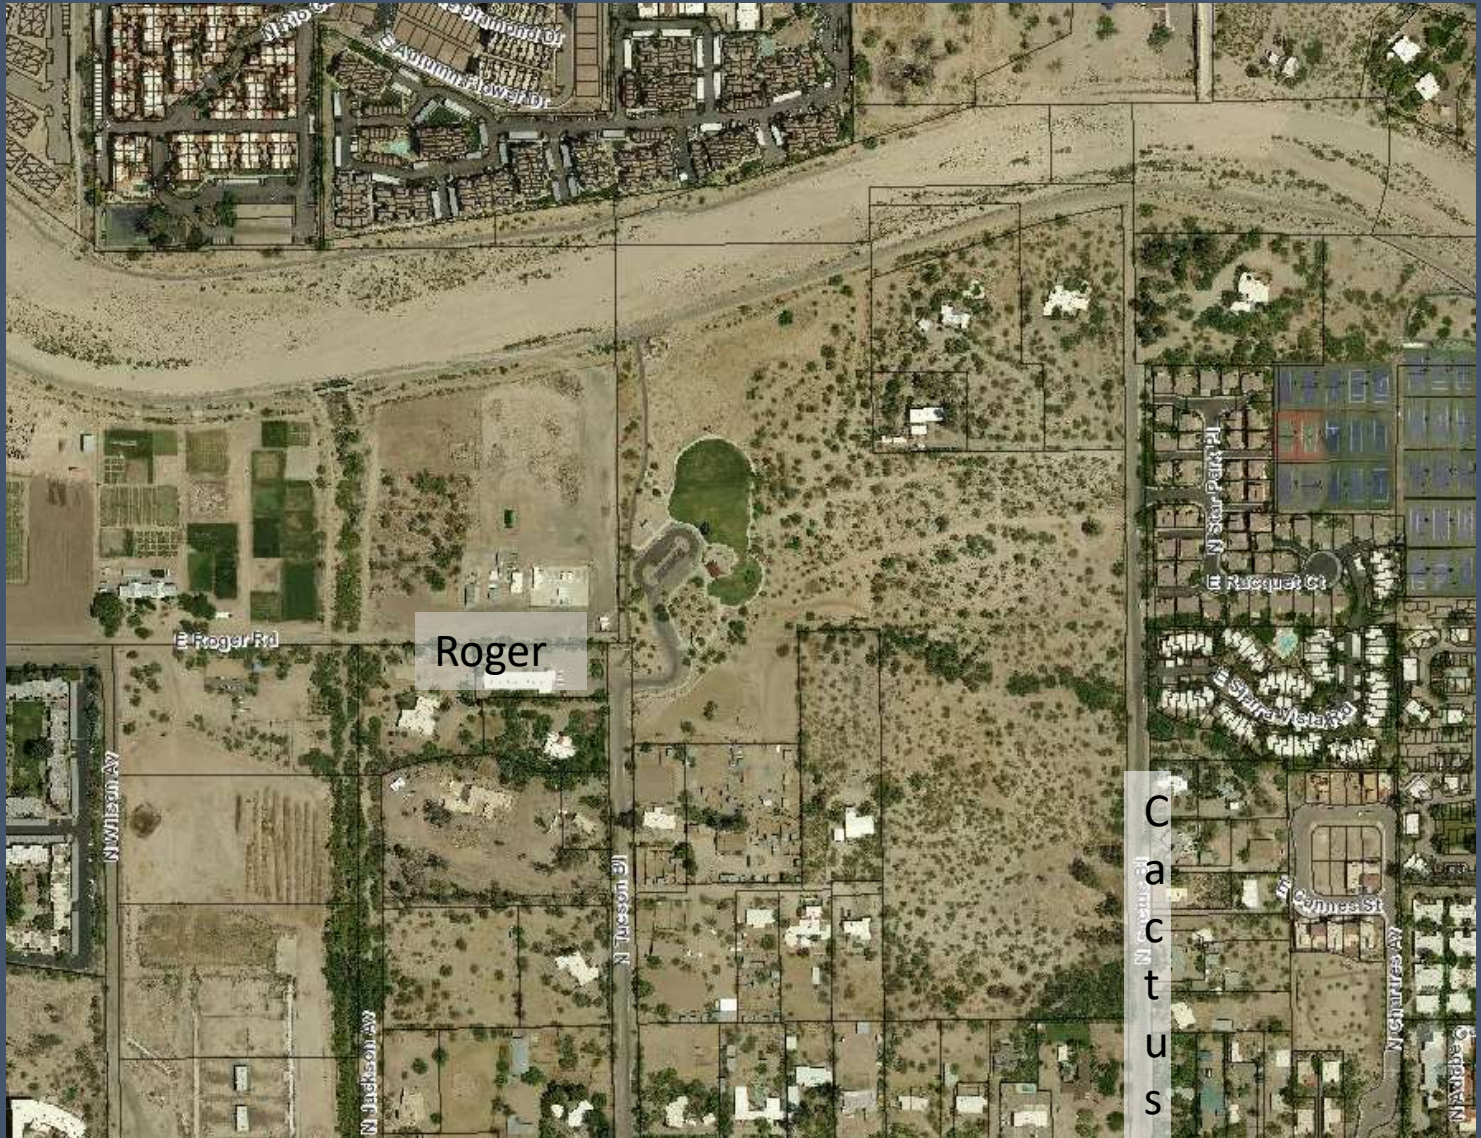
2010

Channel
widening
Turf
expansion

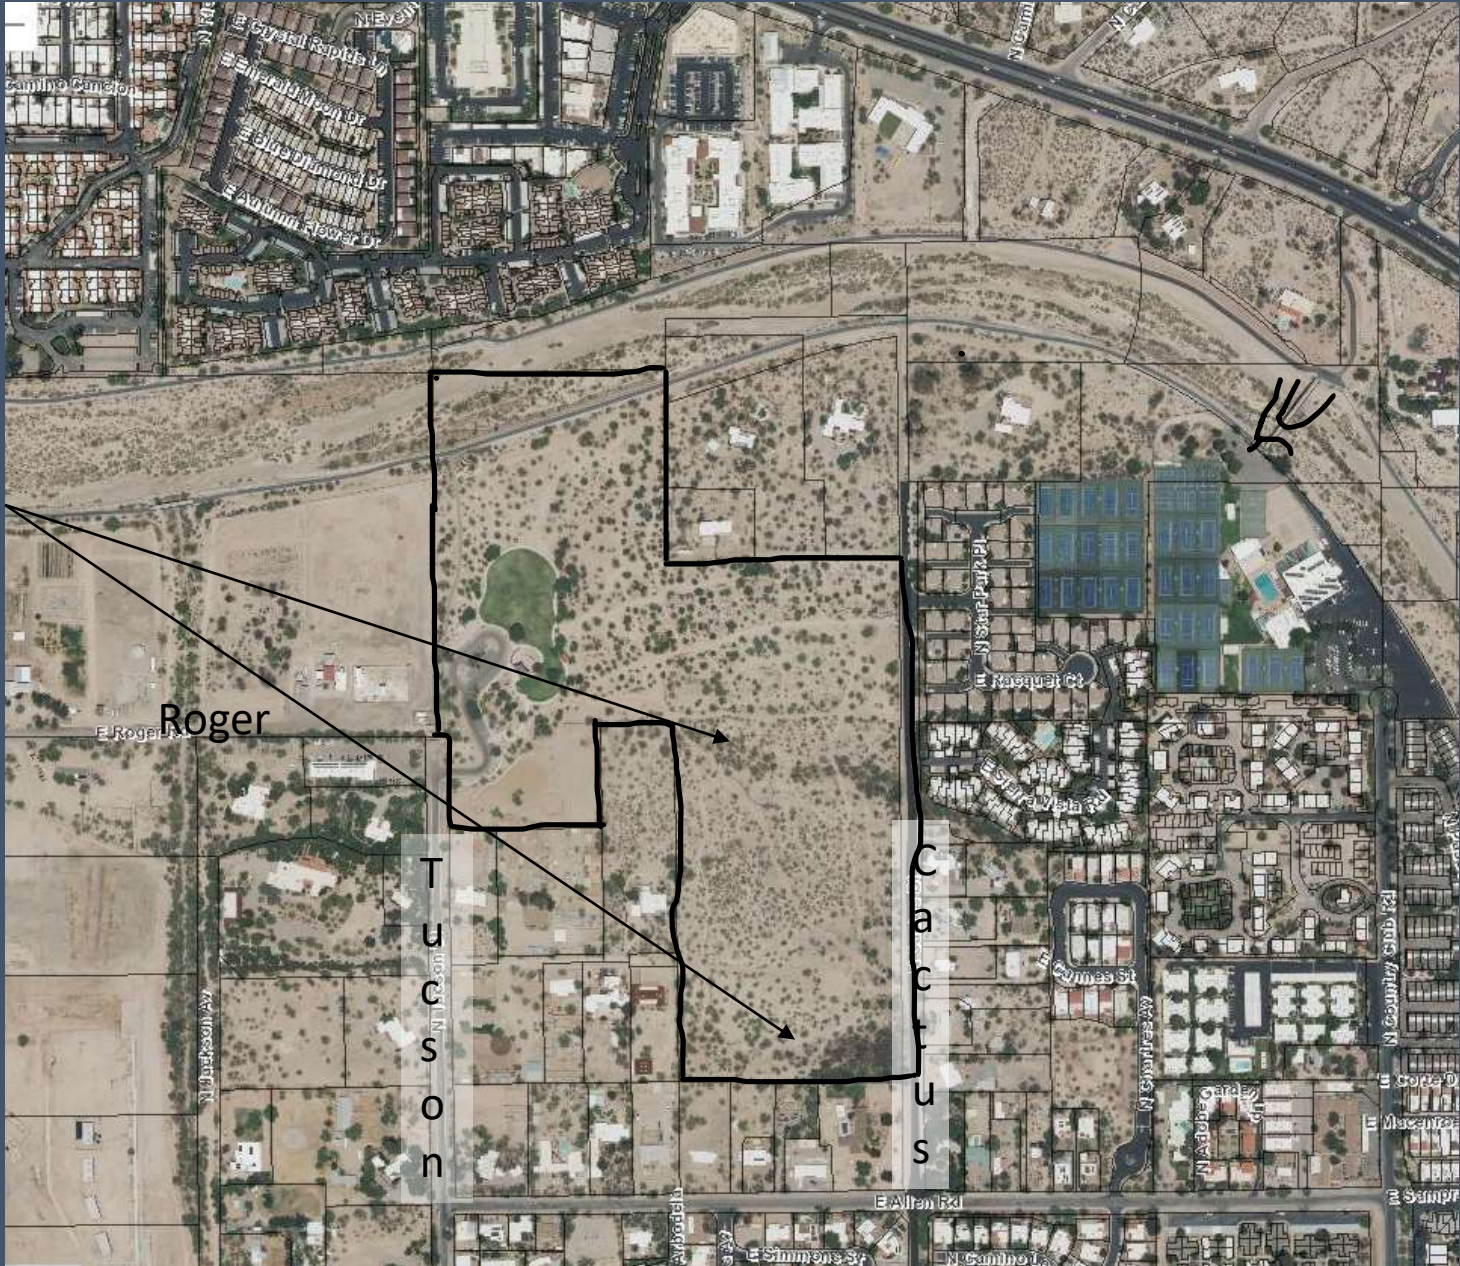
2021

Less riparian
vegetation
More veg
in Rillito
